NASA
Technical
Paper
3223

September 1992

Hot Fire Fatigue Testing Results for the Compliant Combustion Chamber

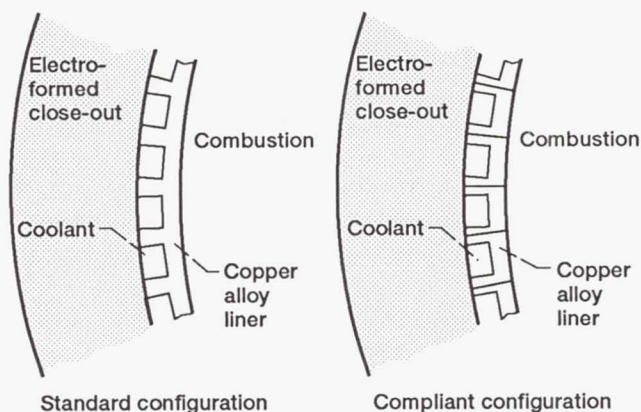
Figure 2. — Standard and compliant in liner comparison.

A variation of the standard configuration was used for the demonstration of the compliant chamber concept. The only difference between the standard configuration and the compliant configuration was a series of slots that were manufactured into the spool (see fig. 2). The purpose of these slots was to allow for the unrestrained thermal expansion of the wall material without imposing excessive thermal strains and, hence, cyclic plastic deformations in the wall. Since the compliant configuration was identical to the standard configuration except for the expansion slots, direct comparisons could be made to show the effects of structural compliance on fatigue life.
